# EXHIBIT “A-1”

February 26, 2016

Insured:	Joseph & Ursy Vitale
Loss Location:	1812 Purdie Lane Maple Glen, PA 19002
Co. Claim #:	0339957135
Date of Loss:	9/4/14
Type of Loss:	Fire
WGI File #:	60294

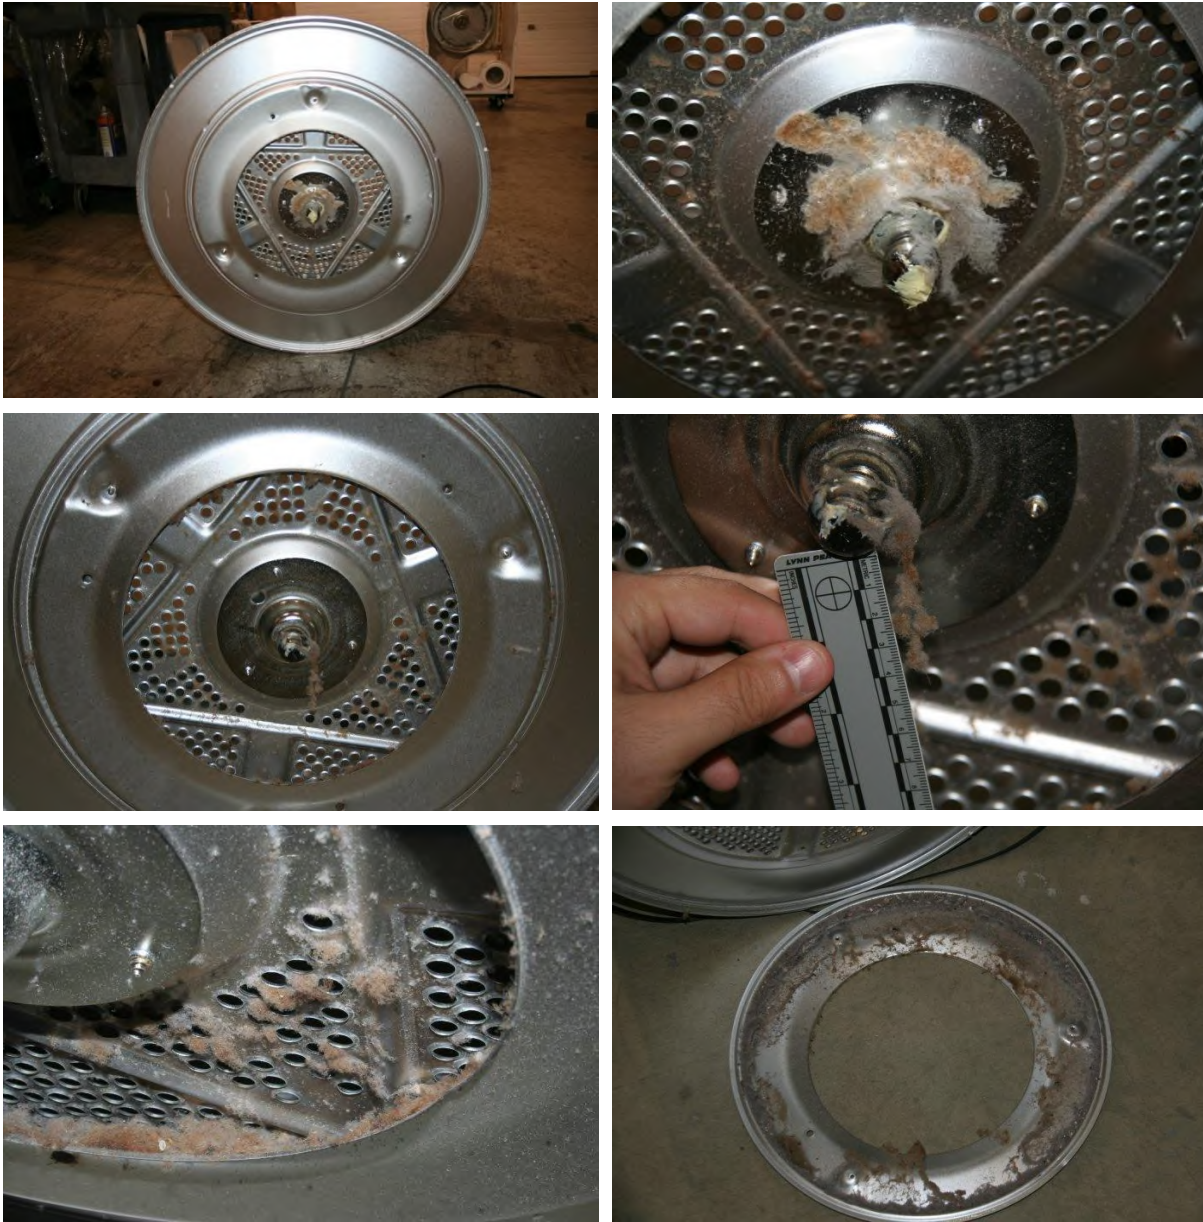
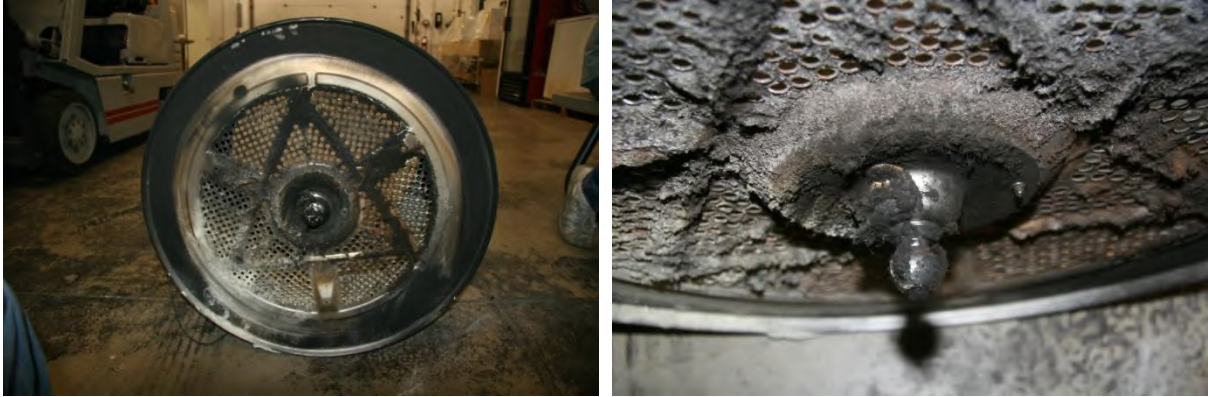
**Photos of Lint Accumulations at the Rear of the Drum (Gas & Electric Models)**

Lint also collects on the rear face of the drum. There are approximately 570 perforated holes on the rear wall of the drum that allow the air to be pulled from the heat diffuser to the rear into the laundry load within the drum. These holes are manufactured by punching through rear wall of the interior of the drum toward the rear. The result is smooth surfaces of each hole inside the drum, but a raised sharp surface on the rear wall of the drum, which further contributes to lint collection behind the drum. The shape and arrangement of these holes also allow lint to escape from the interior of the drum and collect on the rear of the drum and inhibit the lint from being pulled back into the drum.

drum, an additional void space is created that allows for the additional collection of lint between the baffle and the rear face of the drum. In some ignition scenarios, particularly involving the electric dryers, this accumulated lint is the first fuel ignited. In cases where there is a significant quantity of lint accumulated on the rear of the drum, this lint also acts as a secondary fuel load that can assist in either spreading fire to the clothing inside the drum or lint accumulated further downstream in the trap duct.

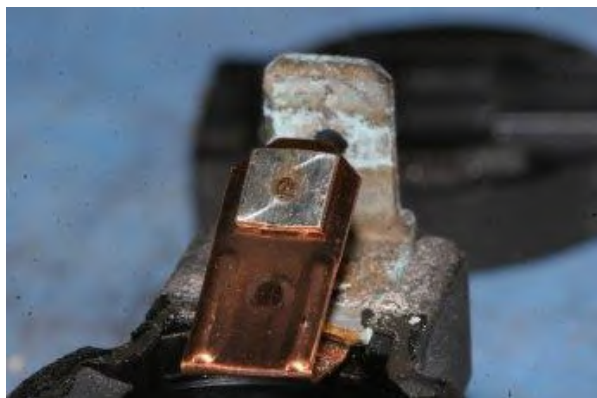
Un-Cycled Contact

Physical evidence of this condition can be found by a visual examination of the contact surfaces of the high limit safety device. The previously described parting arc creates temperatures of thousands of degrees or more. When this occurs, the surface of the contact is melted. As repetition of the parting arc occurs, the surface is melted again and again. Byproducts of the arc include vaporization of the metal contact material, which is observed in the form of a blackened or discolored area at the center of the contact, followed by pitting and eventually deformation of the contact surfaces as repeated cycling occurs. By examining the contacts, one can determine if the dryer had a reduced airflow condition that caused the high limit safety device to activate, and also can gauge the number of times this safety device cycled.
